**TRANSPORTATION SCIENCES CENTER  
ACCIDENT RESEARCH GROUP**

**CALSPAN ON-SITE AIR BAG DEPLOYMENT INVESTIGATION  
CALSPAN CASE NO. 95-2  
VEHICLE: 1994 FORD F-150 PICKUP TRUCK  
LOCATION: [REDACTED] MS  
CRASH DATE: [REDACTED] 1994**

Contract No. DTNH22-94-D-07058

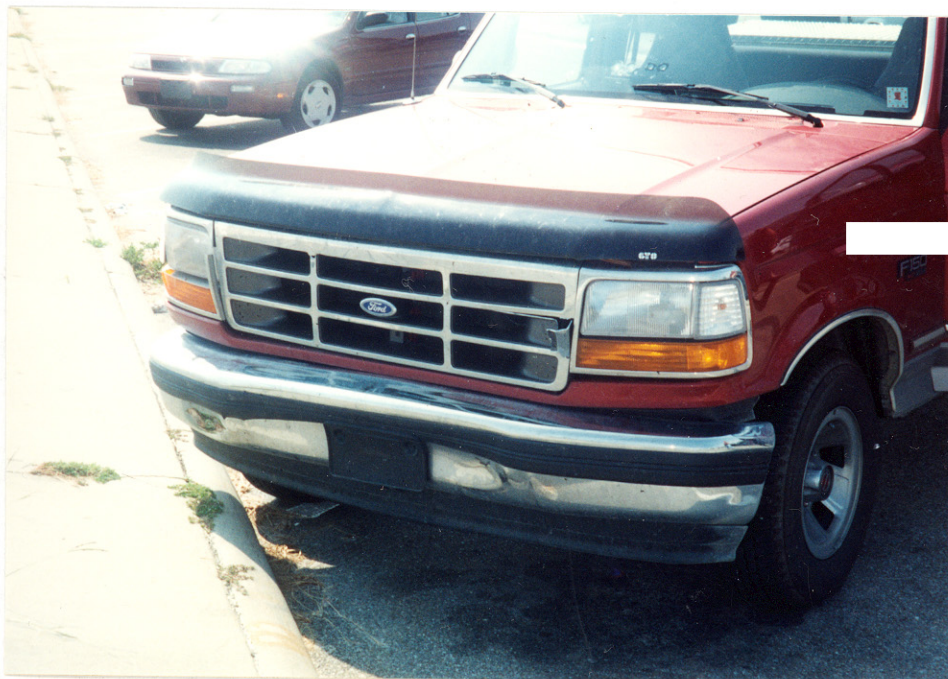
2. Frontal damage to the Ford F-150 pickup truck.

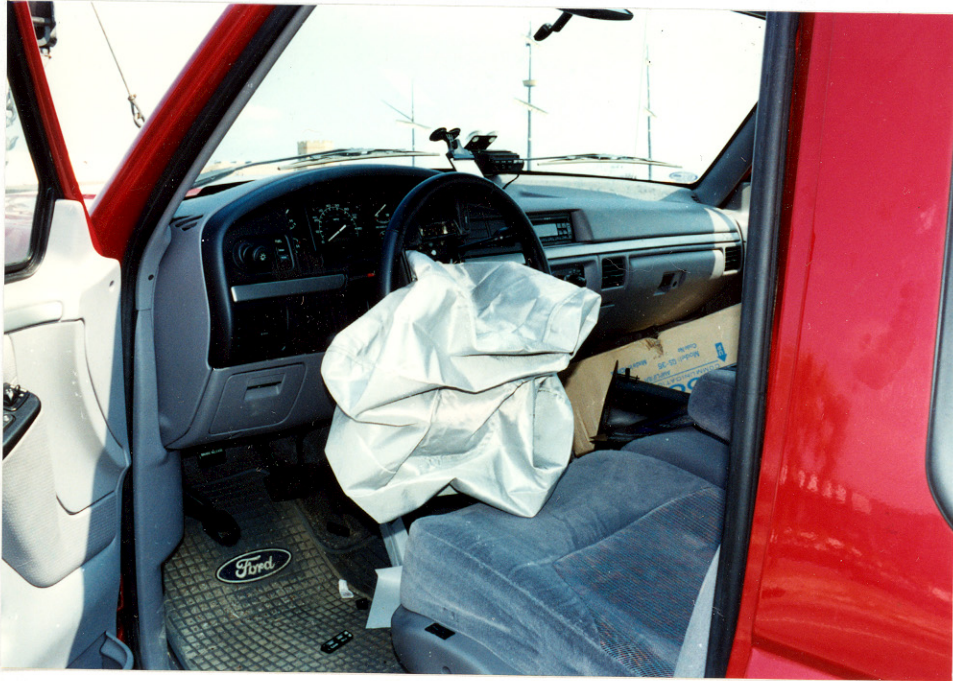
3. Overall view of the Ford's interior and the deployed driver's side air bag.

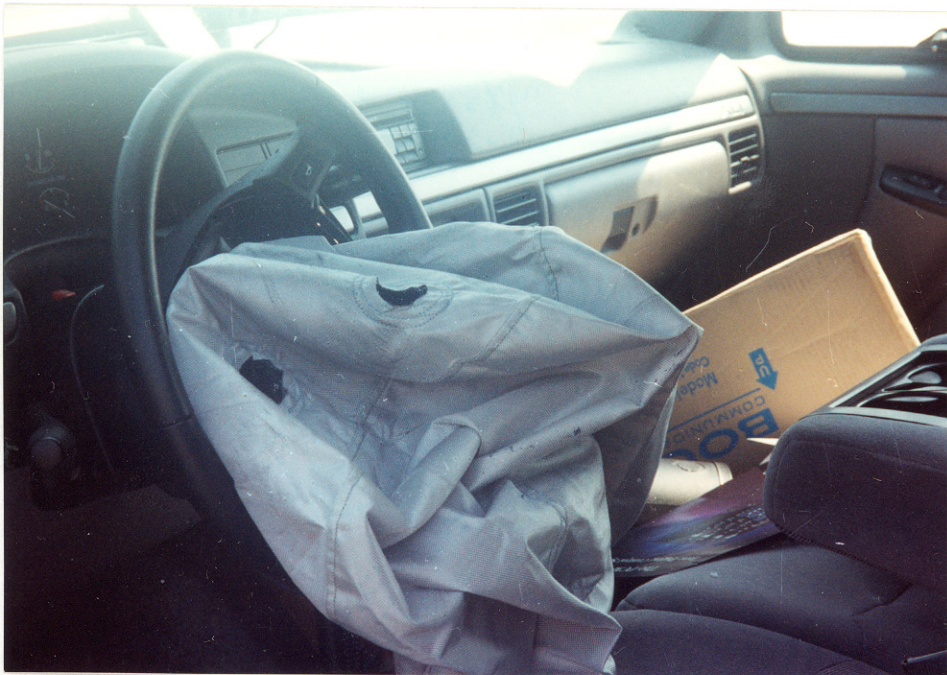
4. Close-up view of the deployed air bag and the separated upper module cover flap.

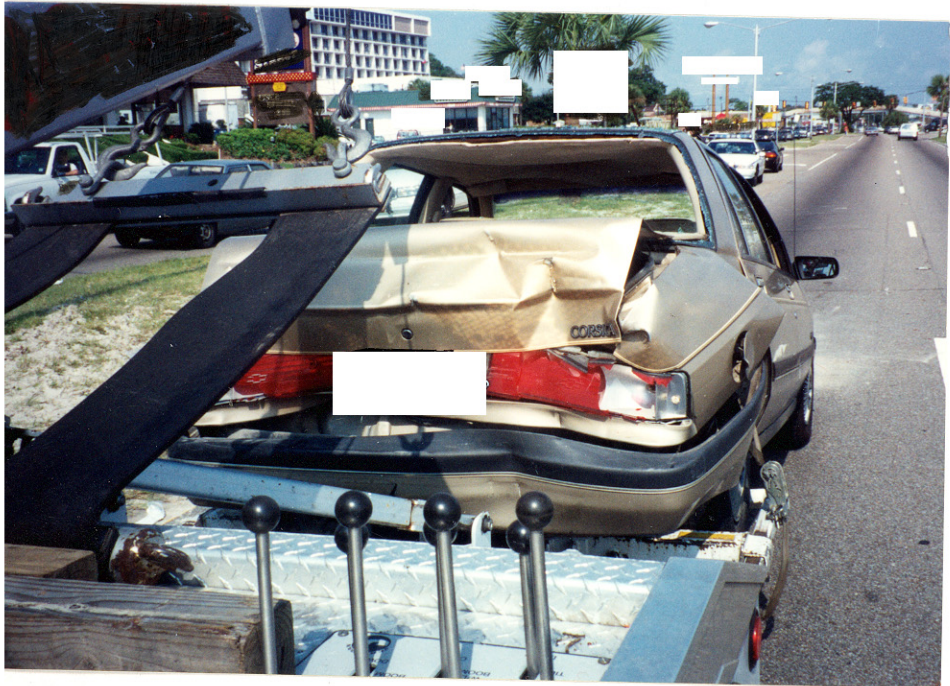
5. Rear damage to the Chevrolet Corsica.

The Chevrolet Corsica sustained moderately severe damage that was distributed across the rear plane of the vehicle. Maximum crush was estimated at 30-36 cm (12-14") on the rear bumper approximately 30 cm (12") right of center from the on-scene police photographs. In addition to the bumper crush, the face of the truck lid was displaced approximately 20 cm (8") forward from the 6 o'clock impact force.

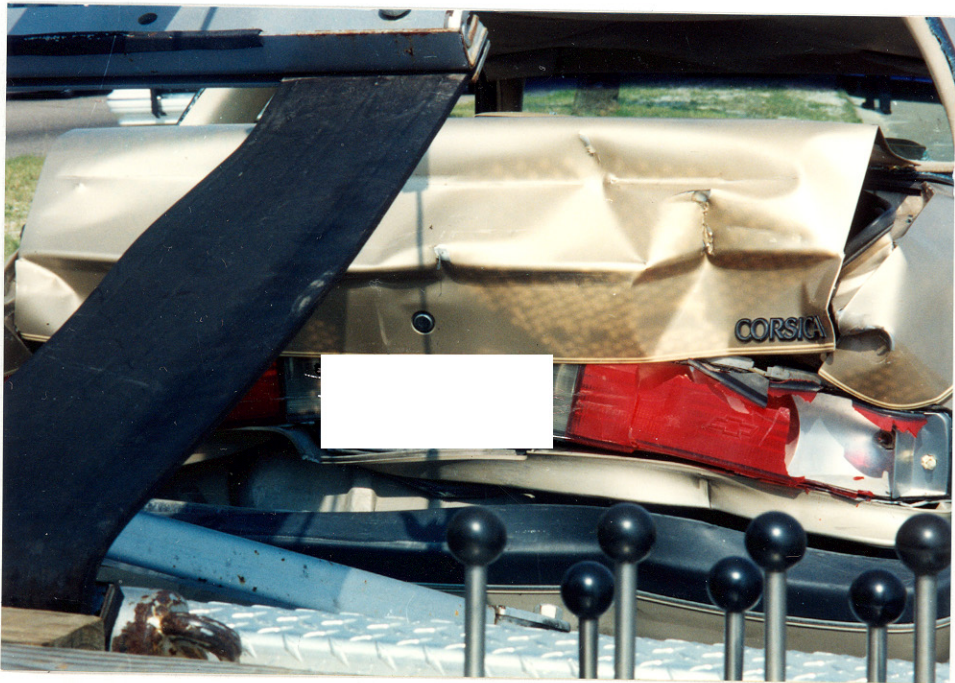
6. Close-up view of the rear damage to the Corsica.

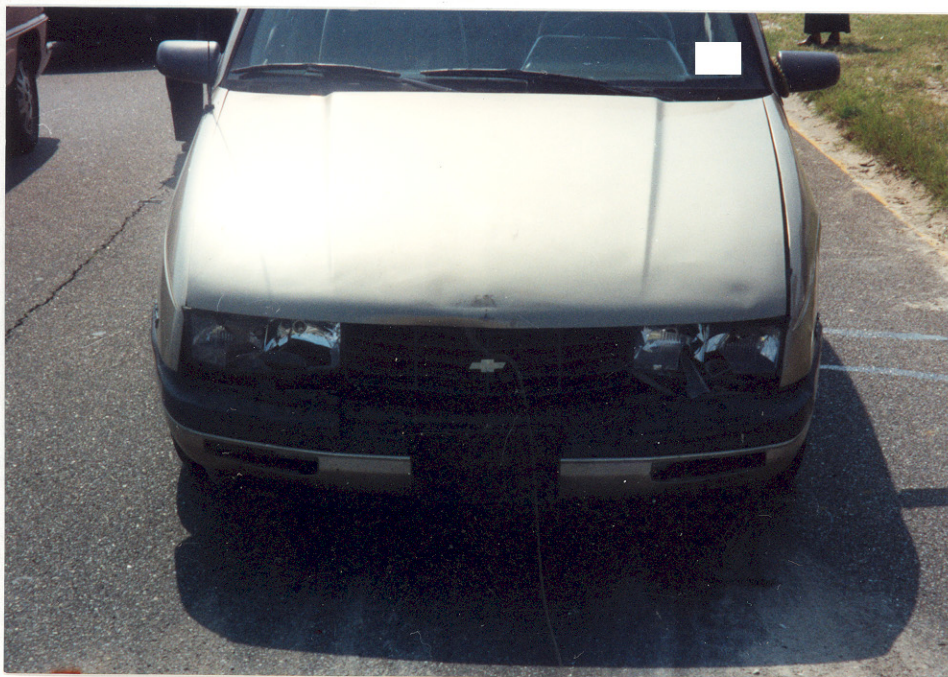
**8. Frontal damage to the Corsica from secondary contact with the Nissan 240 SX.**

The frontal area of the Chevrolet Corsica impacted the rear of the stopped Nissan which resulted in minor damage to the grille, headlamps, and hood.

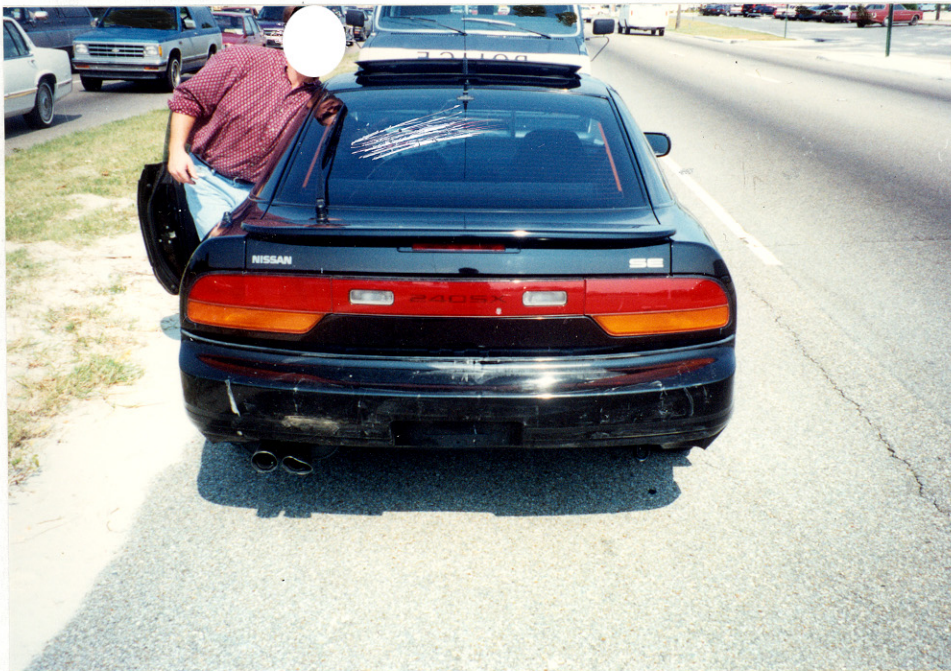
**9. Rear damage to the bumper fascia of the Nissan 240 SX.**

The rear of the Nissan 240 SX minor damage from its impact sequence with the Chevrolet Corsica. Direct contact damage was distributed across the rear bumper fascia of the Nissan. There was no damage to the taillamp lenses or hatchback of the vehicle.

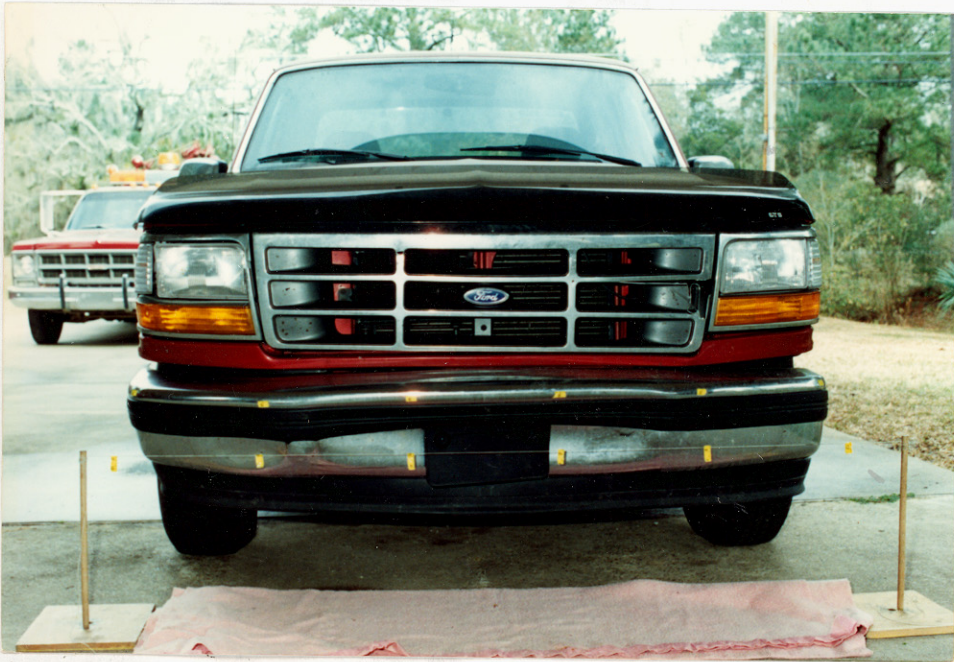
3. Frontal damage to the involved 1994 Ford F-150 pickup truck.

Exterior: The 1994 Ford F-150 pickup sustained minor frontal damage from its impact sequence with the rear of vehicle #2. Maximum crush was 9.1 cm (3.6") located at the mid point of the front bumper face below the rub strip, behind the plastic license plate frame. The direct contact damage width was 139.7 cm (55.0") which extended across the bumper and grille from headlamp-to-headlamp. The direct contact damage consisted of abrasions on the bumper rub strip and cracks across the full width of the plastic grille. The combined induced and direct contact damage width was 182.2 cm (71.8") which extended

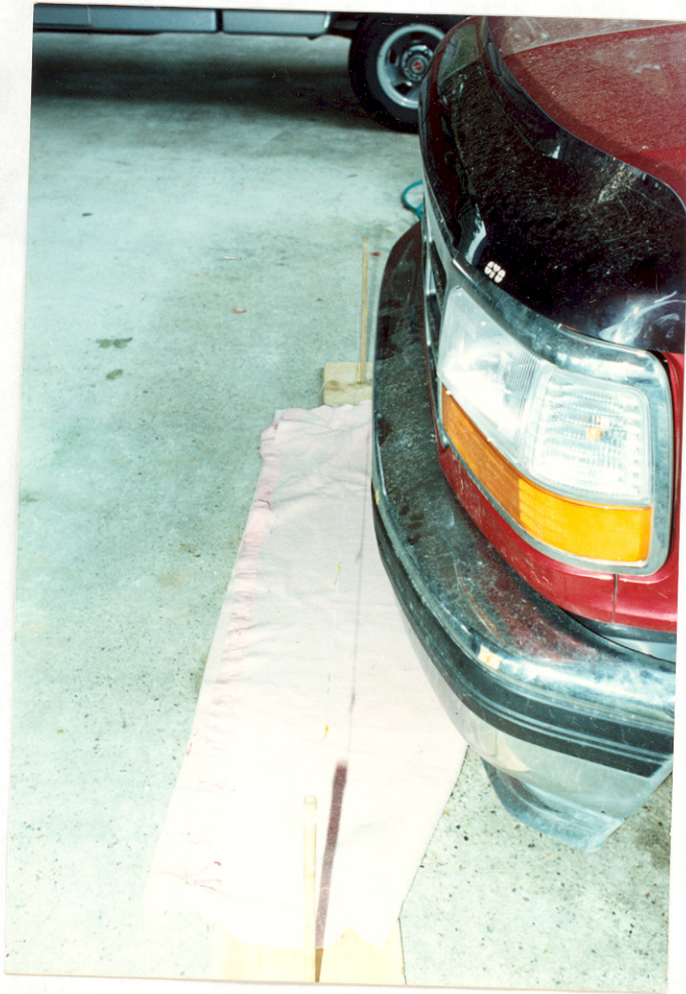
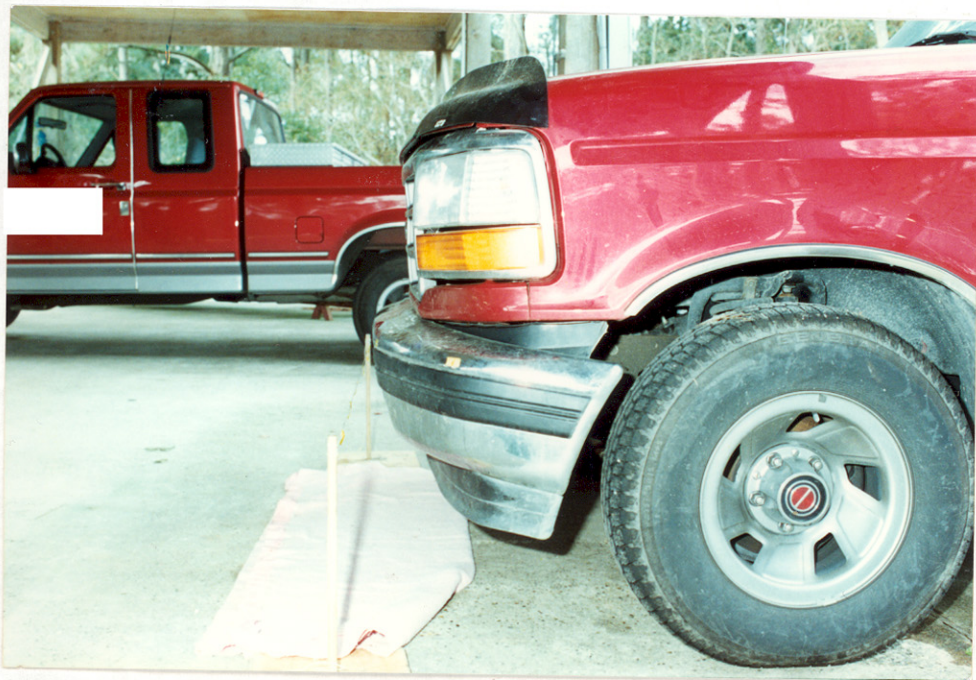
5. & 6. Profile views at the left front corner documenting the extent of crush.

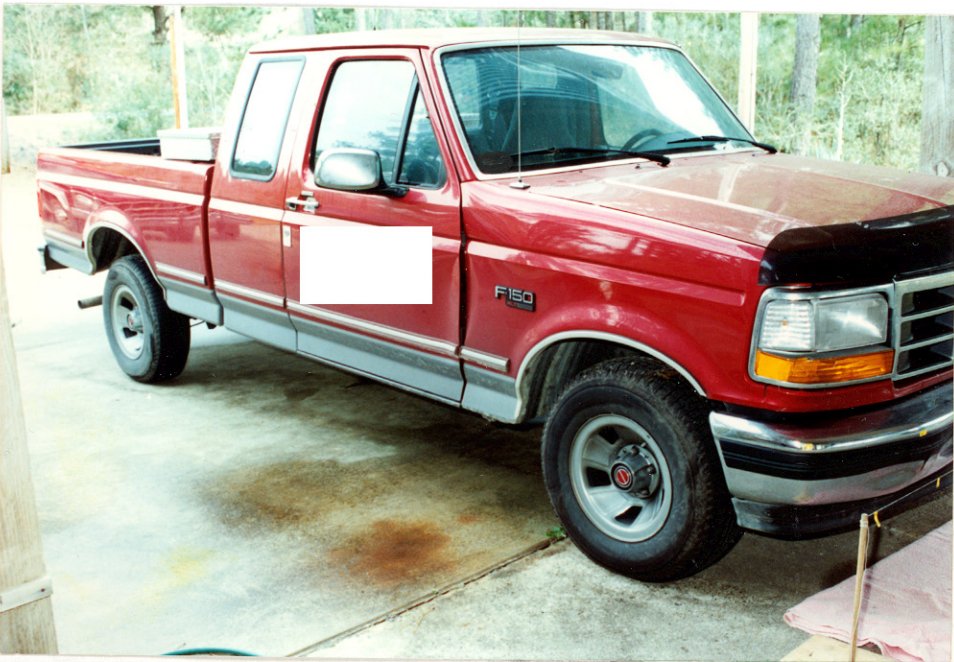
10. Right side view and displacement of the right front fender.

Damaged components consisted of the front bumper, bumper rub strip, grille, right headlamp bezel, and the right front fender and door. The right front fender was displaced rearward by the impact forces. During the extrication of the driver, rescue personnel opened the right door and the leading edge of the door contacted and deformed the trailing edge of the fender. In addition, the leading edge of the right door was damaged.

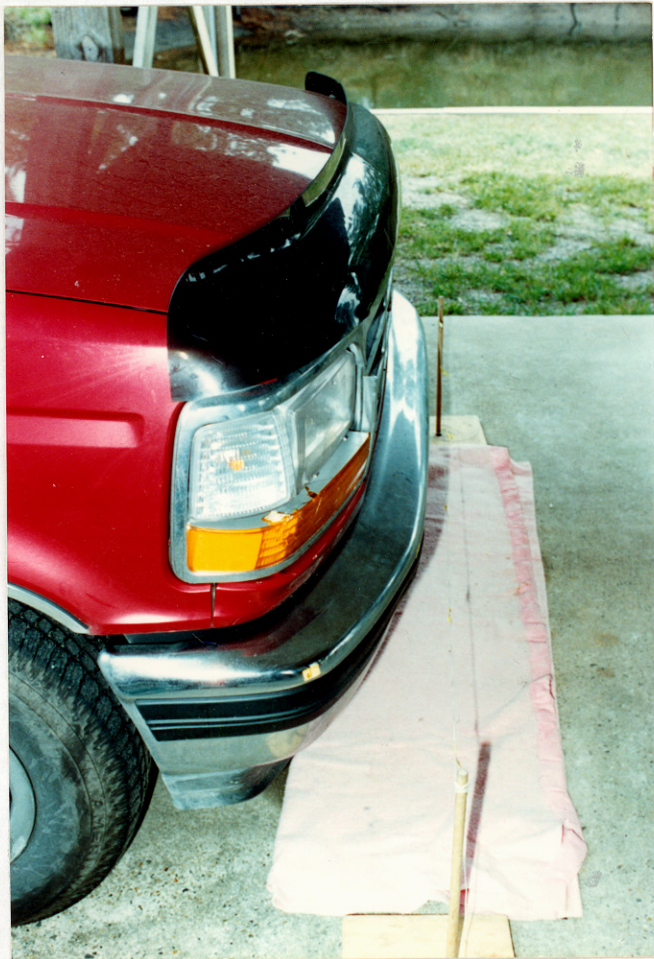
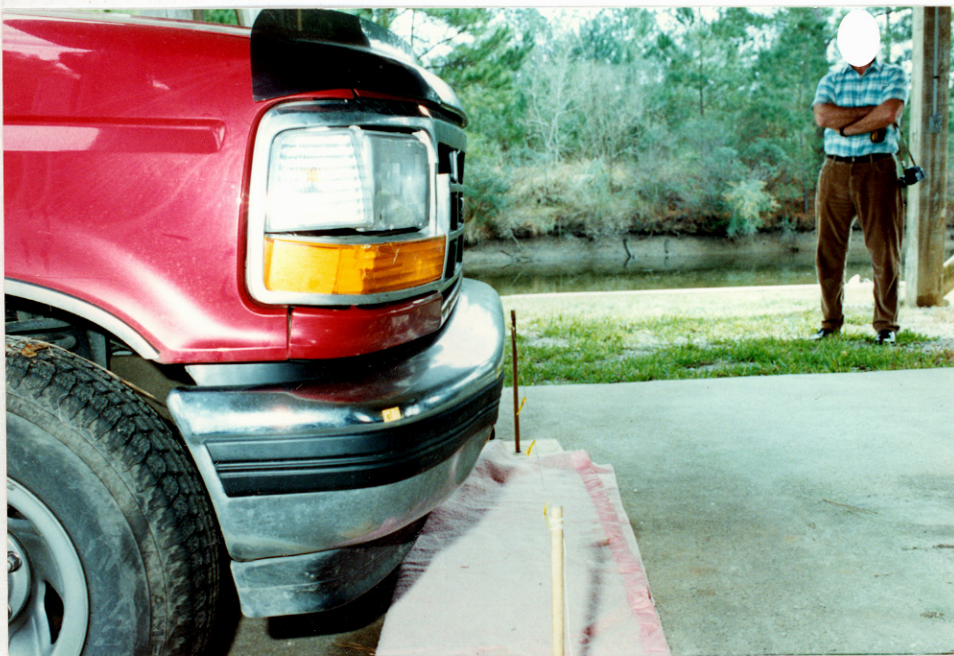
11. & 12. Profile views at the right front corner documenting the extent of crush.

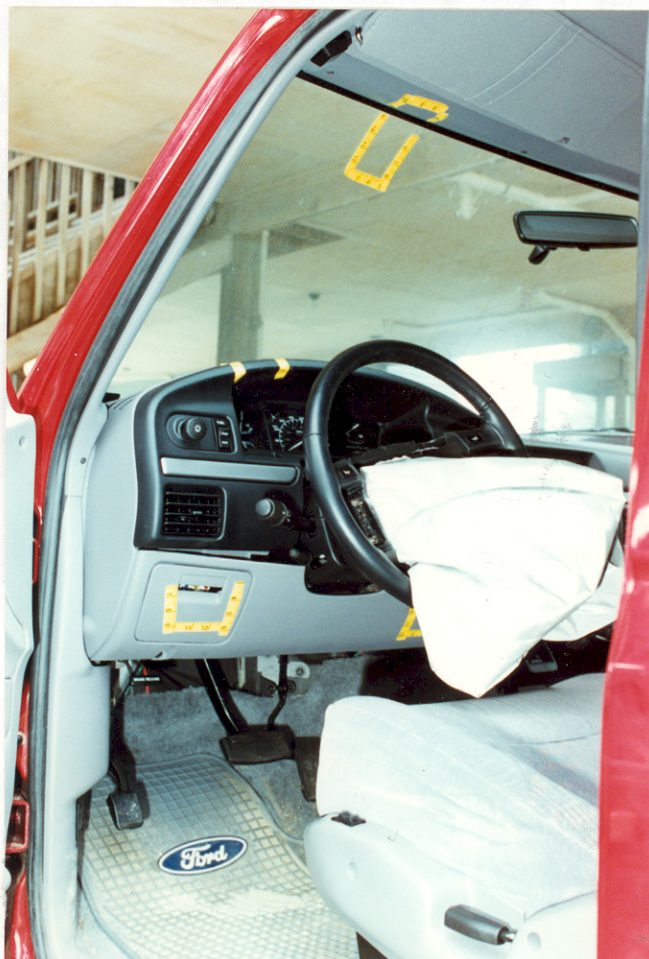
15. Overall view of the driver's trajectory and contact points.

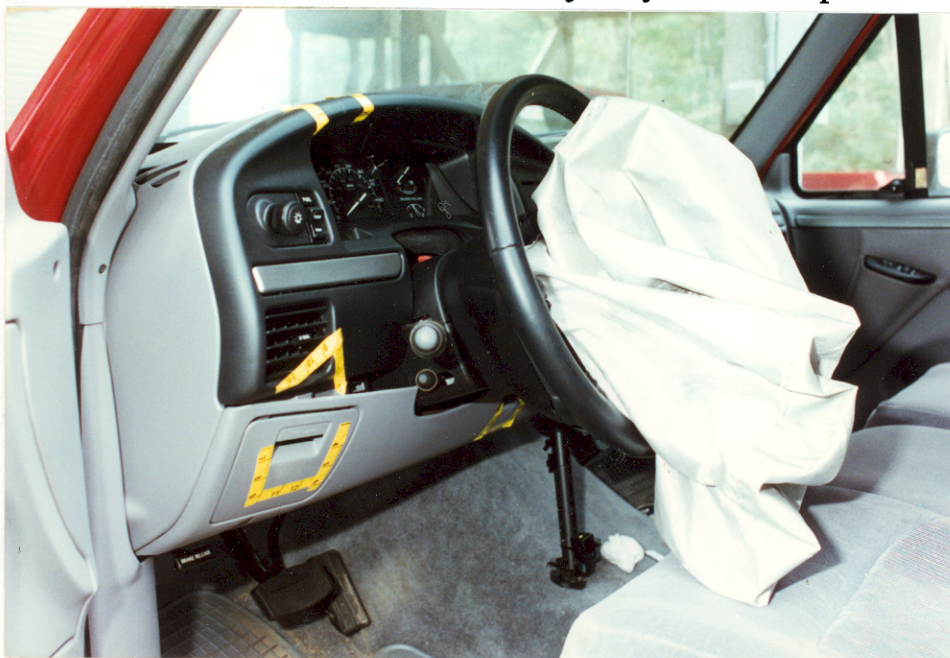
16. Driver's knee contacts to the bolster and mid instrument panel.

The driver's left knee contacted the mid instrument panel at the base of the vent louver and the fuse box cover that was incorporated into the knee bolster. The knee contact scuffed the components 64.1-71.1 cm (25.25-28.0") left of the vehicle's centerline and 17.1-20.3 cm (6.75-8.0") below the chrome trim which separated the mid and upper instrument panels. His right knee scuffed the knee bolster 25.4-30.5 cm (10.0-12.0") left of the centerline and 20.3-22.9 cm (8.0-9.0") below the referenced trim strip. There was no internal damage to the bolster as documented in Photograph No. 21 of Attachment B.

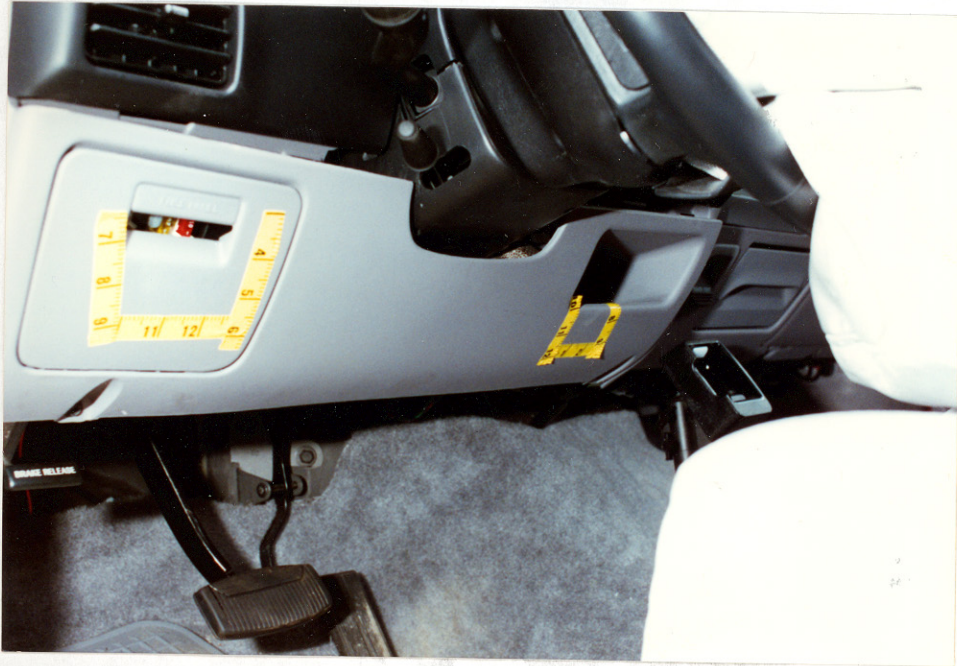
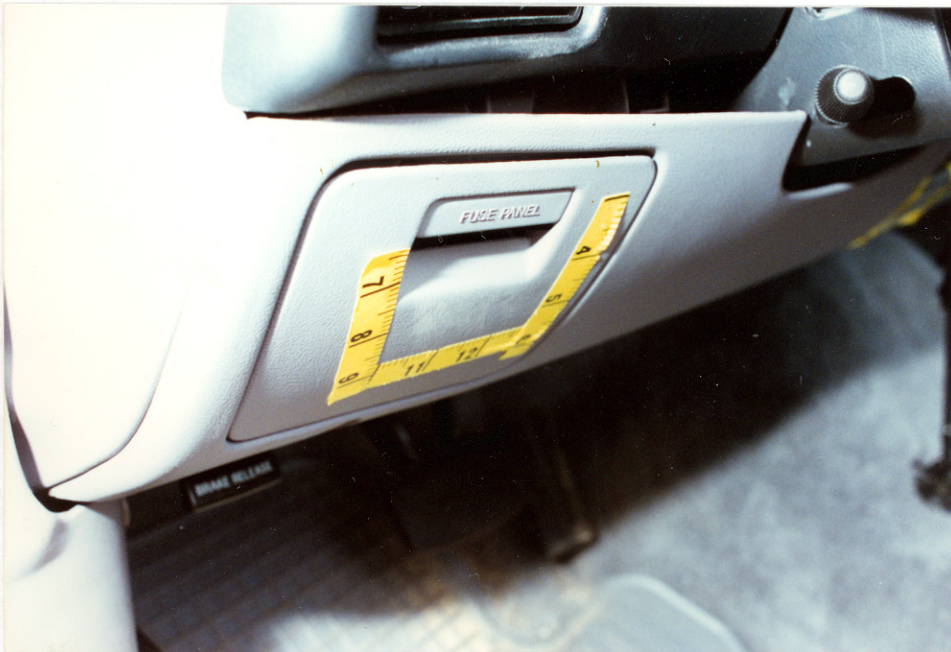
17. & 18. Close-up views of the left knee contact.

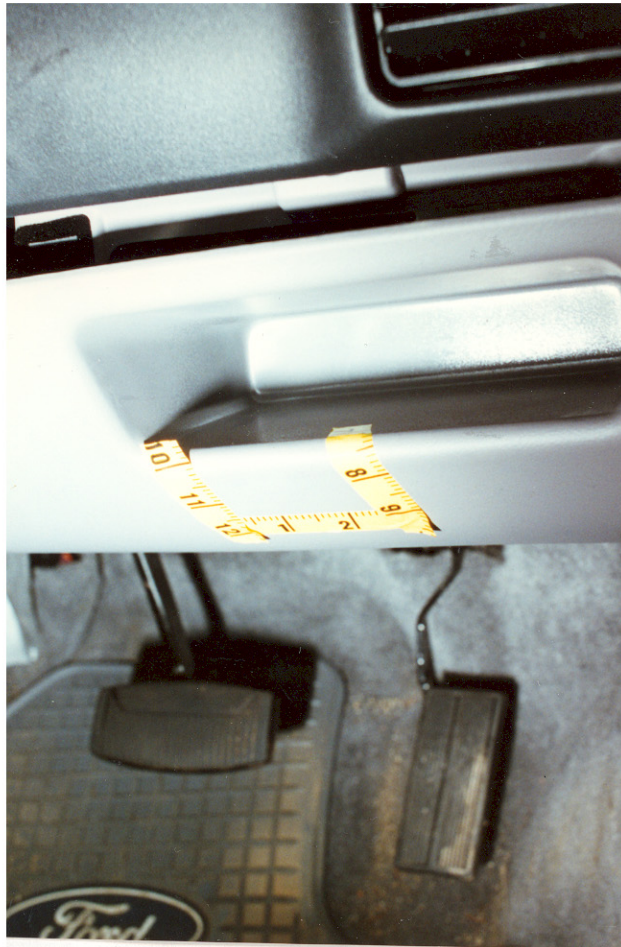
19. Right knee contact (scuff) to the bolster.

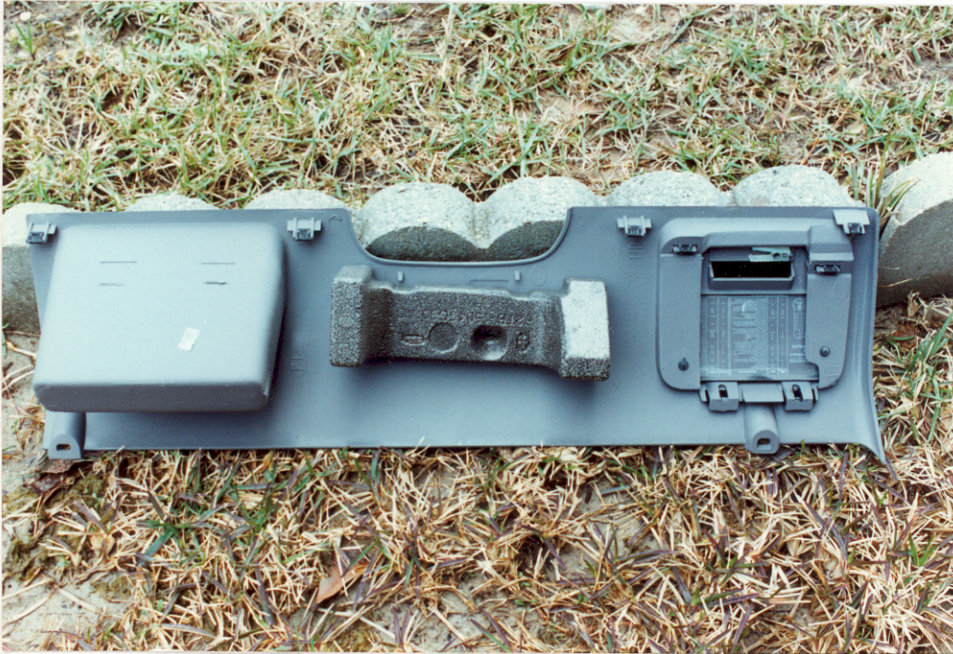
21. Back side of bolster, no damage.

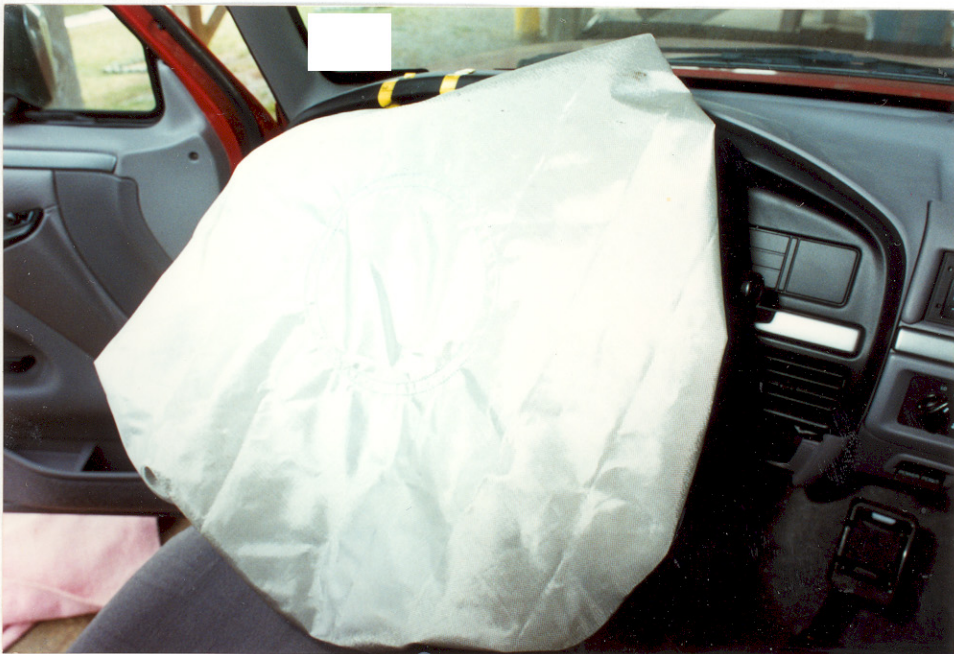
22. Deployed driver's side air bag.

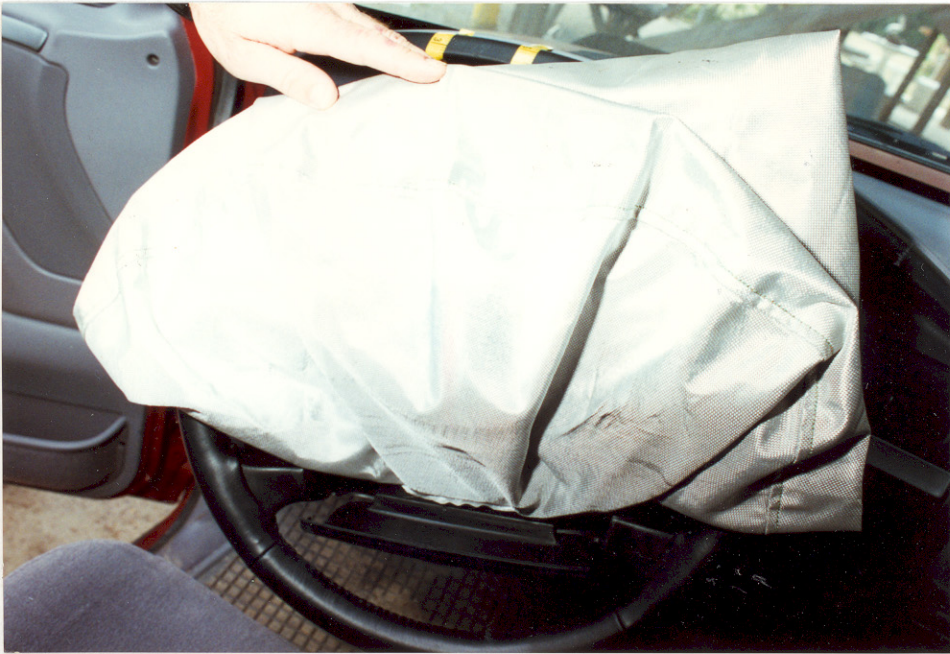
23. Black vinyl transfers at the 6 o'clock sector from the lower module cover flap.

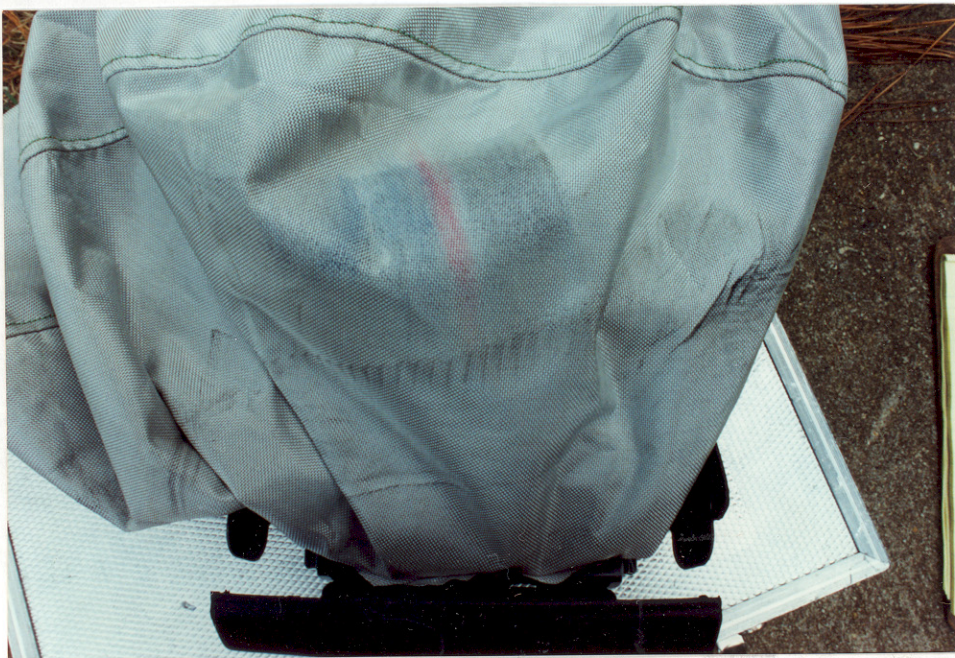
24. Driver's shirt fabric transfers on the air bag at the 6 o'clock sector.

transferred on the air bag at the 6 o'clock sector (refer to Photograph No. 24). In addition to the shirt damage, the driver had a leather bound pocket calendar in one of the shirt pockets. The side of the leather calendar that was exposed to the air bag had a white transfer from the air bag fabric that was both patterned and irregular (refer to Photograph Nos. 54 and 55 of Attachment B). Fabric fibers from the driver's plaid shirt were embedded into the leather calendar in the area of the air bag transfer. The driver's T-shirt was also torn in an irregular pattern over the left chest area.

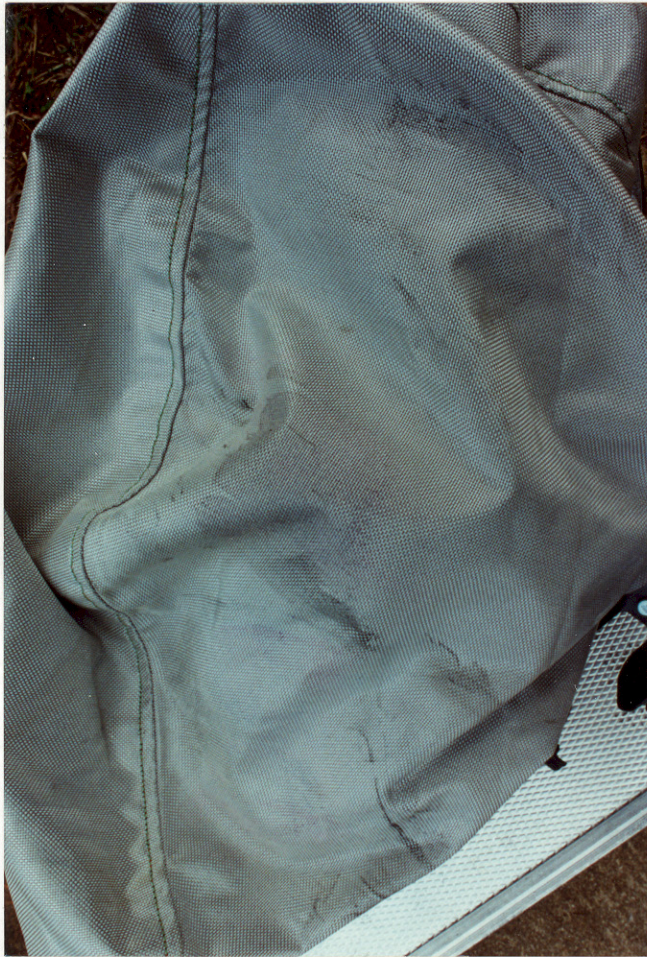
25. Fabric transfers on the right side of the air bag forward of the peripheral seam.

A black vinyl transfer was noted to the right side surface of the bag and was located forward of the peripheral seam. The transfer began 10.2 cm (4.0") below the right vent port and extended approximately 30.4 cm (12.0") downward and 6.4-15.2 cm (2.5-6.0") forward of the seam toward the generator. There were color transfers from the driver's plaid shirt on the air bag at the 3 and 6 o'clock sectors. A large purplish transfer was located on the right side of the air bag which began 22.2 cm (8.75") below the right vent port and extended downward approximately 22.9 cm (8.75"). The upper edge of the transfer was 4.4-12.1 cm (1.75-4.75") forward of the peripheral seam while the lower edge began at the seam and extended 10.2 cm (4.0") forward. In addition, there was a patterned blue, red, and black shirt fabric transfer on the air bag at the 6 o'clock position. The vertically orientated transfer (refer to Photograph No. 24) was located 4.4 cm (1.75") forward of the peripheral seam and was 7.0 cm (2.75") in height and 9.5 cm (3.75") in width.

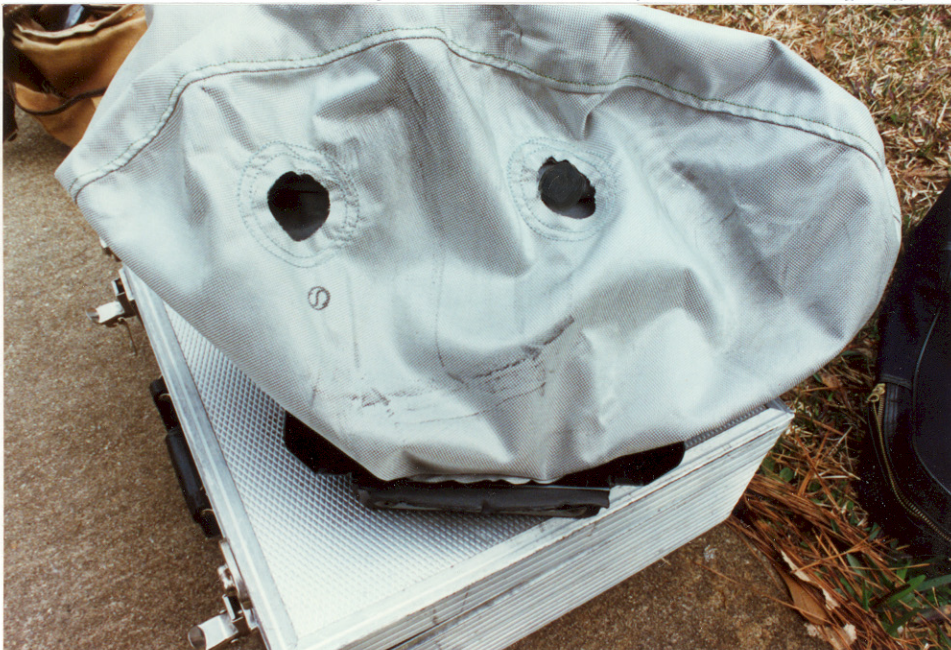
26. Black vinyl transfers at the 12 o'clock sector from the upper module cover flap.

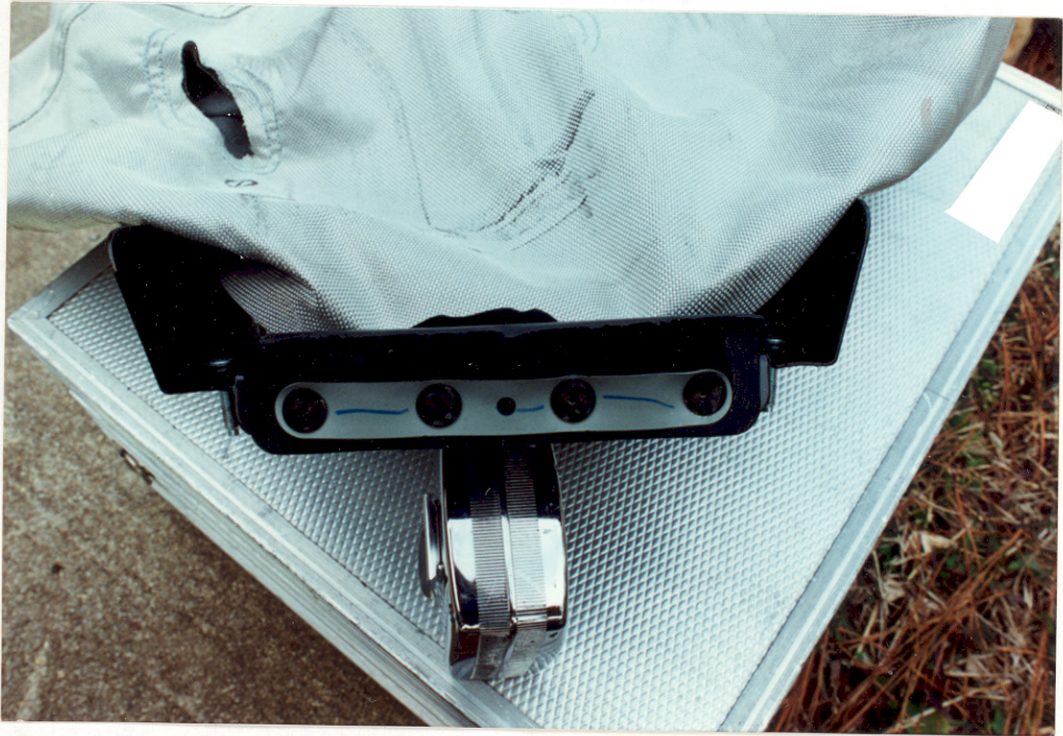
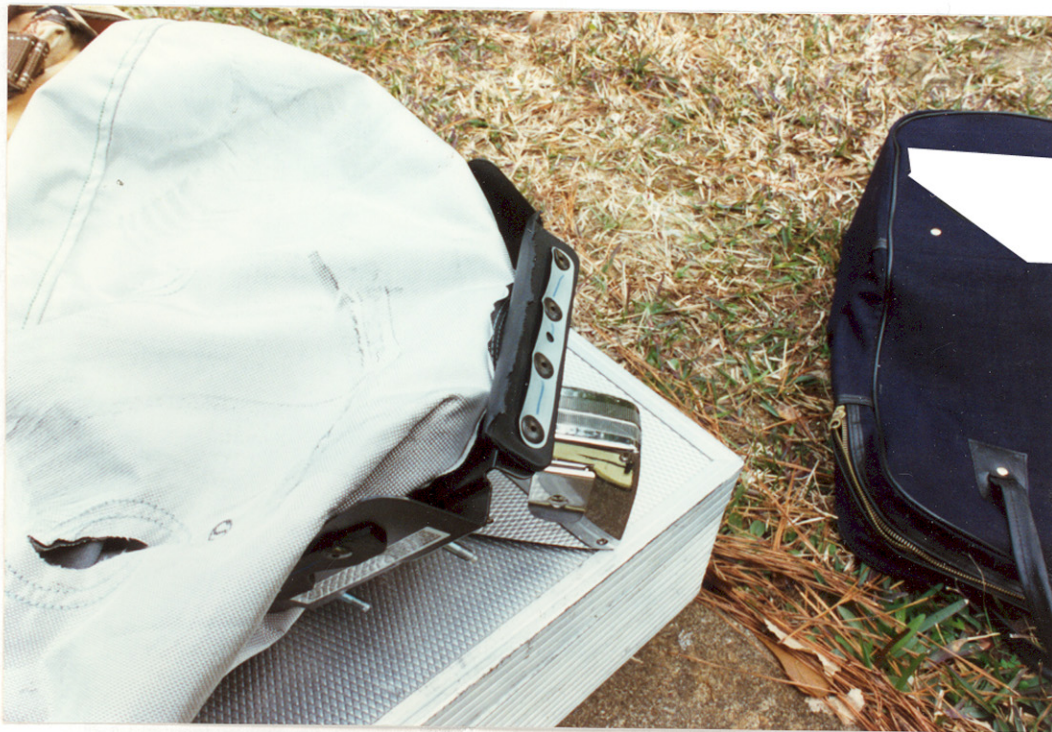
27. & 28. Separated upper module cover flap.

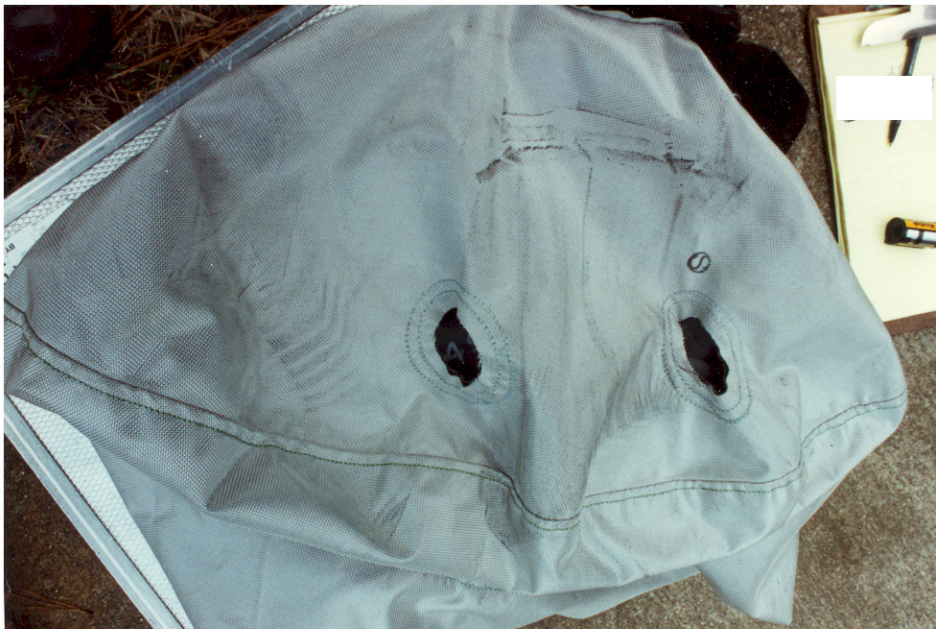
29. Upper flap vinyl transfers and vent ports.

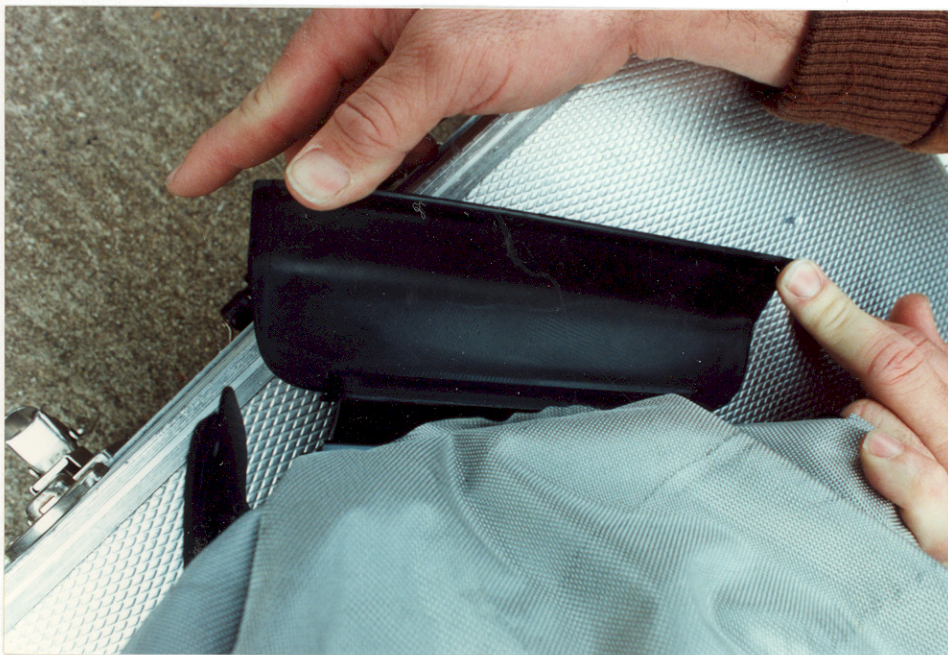
30. Air bag fabric transfers on the inner surface of the lower flap.

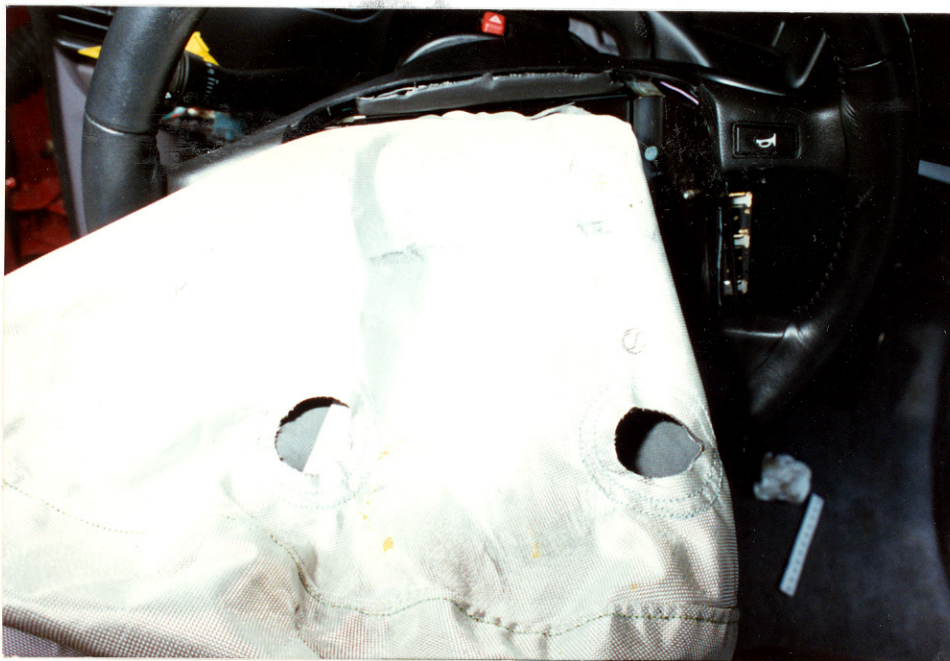
31. Additional view of the separated upper module cover flap.

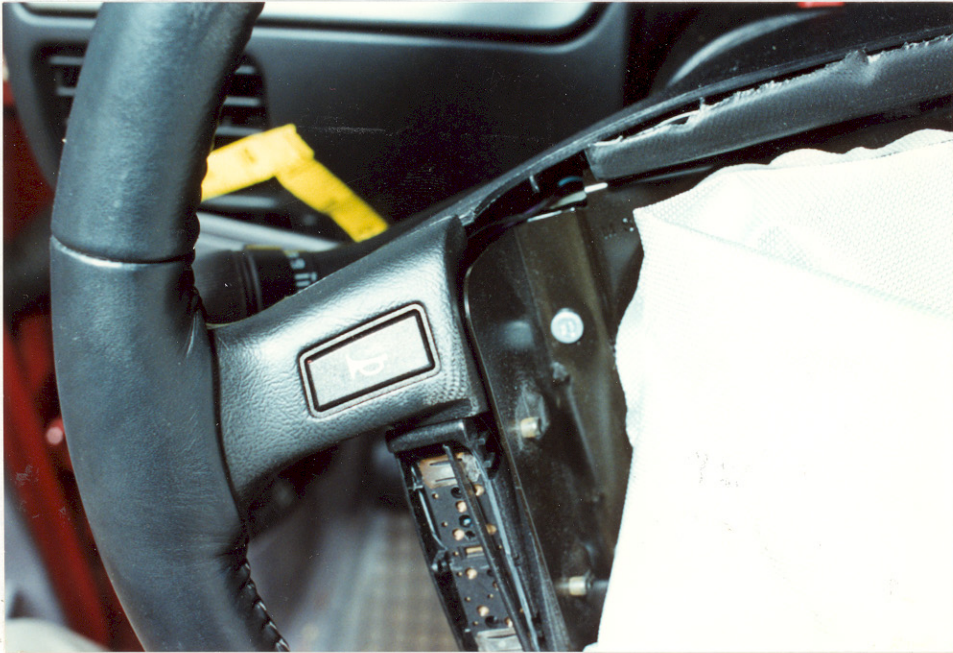
33. Air bag fabric transfer on the left upper steering wheel spoke.

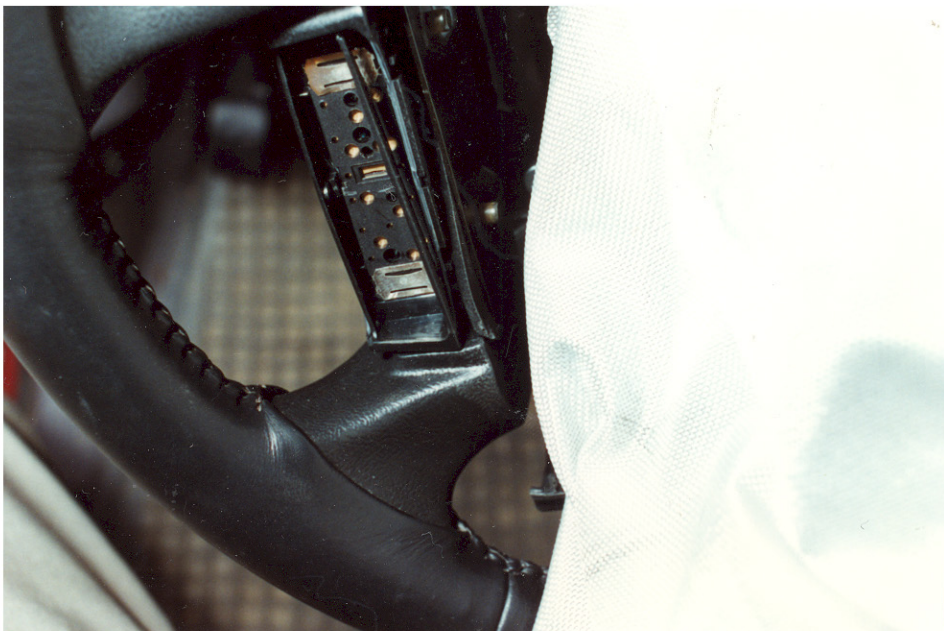
34. Displaced cruise control switches and fabric transfer on the left lower spoke.

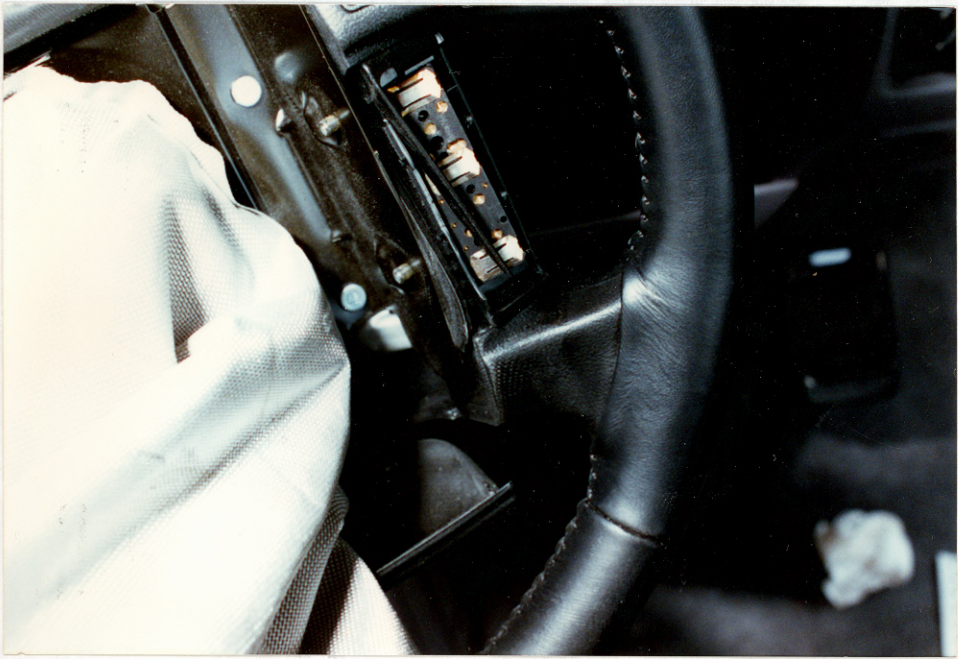
35. Damaged right cruise control switches and fabric transfers to the right lower spoke.

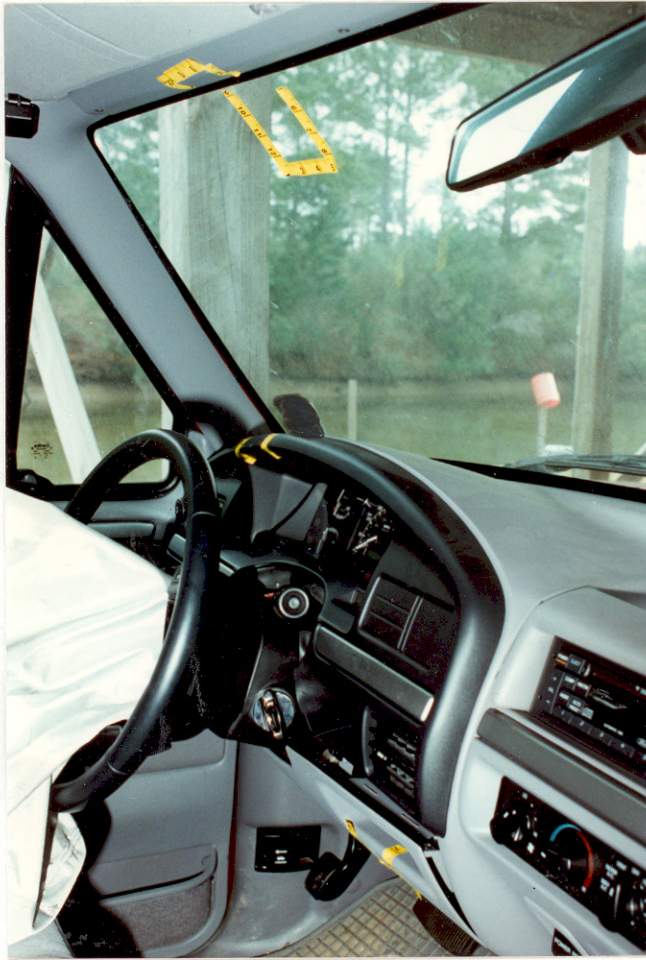
37. Driver's forehead contact to the windshield header and windshield.

**Bag Vehicle):** The left sunvisor was probably contacted by the driver's forehead or the anterior aspect of his scalp. There was no compression of the visor, however, its location with respect to the header contact point presented itself as a probable contact point. There appeared to be a faint scuff/transfer (possible tissue transfer) on the sunvisor in Photograph No. 15 that was located above the header contact point and to the left of the elastic band. It should be noted that this scuff did not appear visible during our inspection of the vehicle which occurred on [REDACTED] 1995.
